Final Remedial Investigation Report

Mansfield Trail Dump Site, Operable
Unit 2 (Groundwater)
Remedial Investigation/Feasibility Study
Byram Township, New Jersey

May 10, 2019

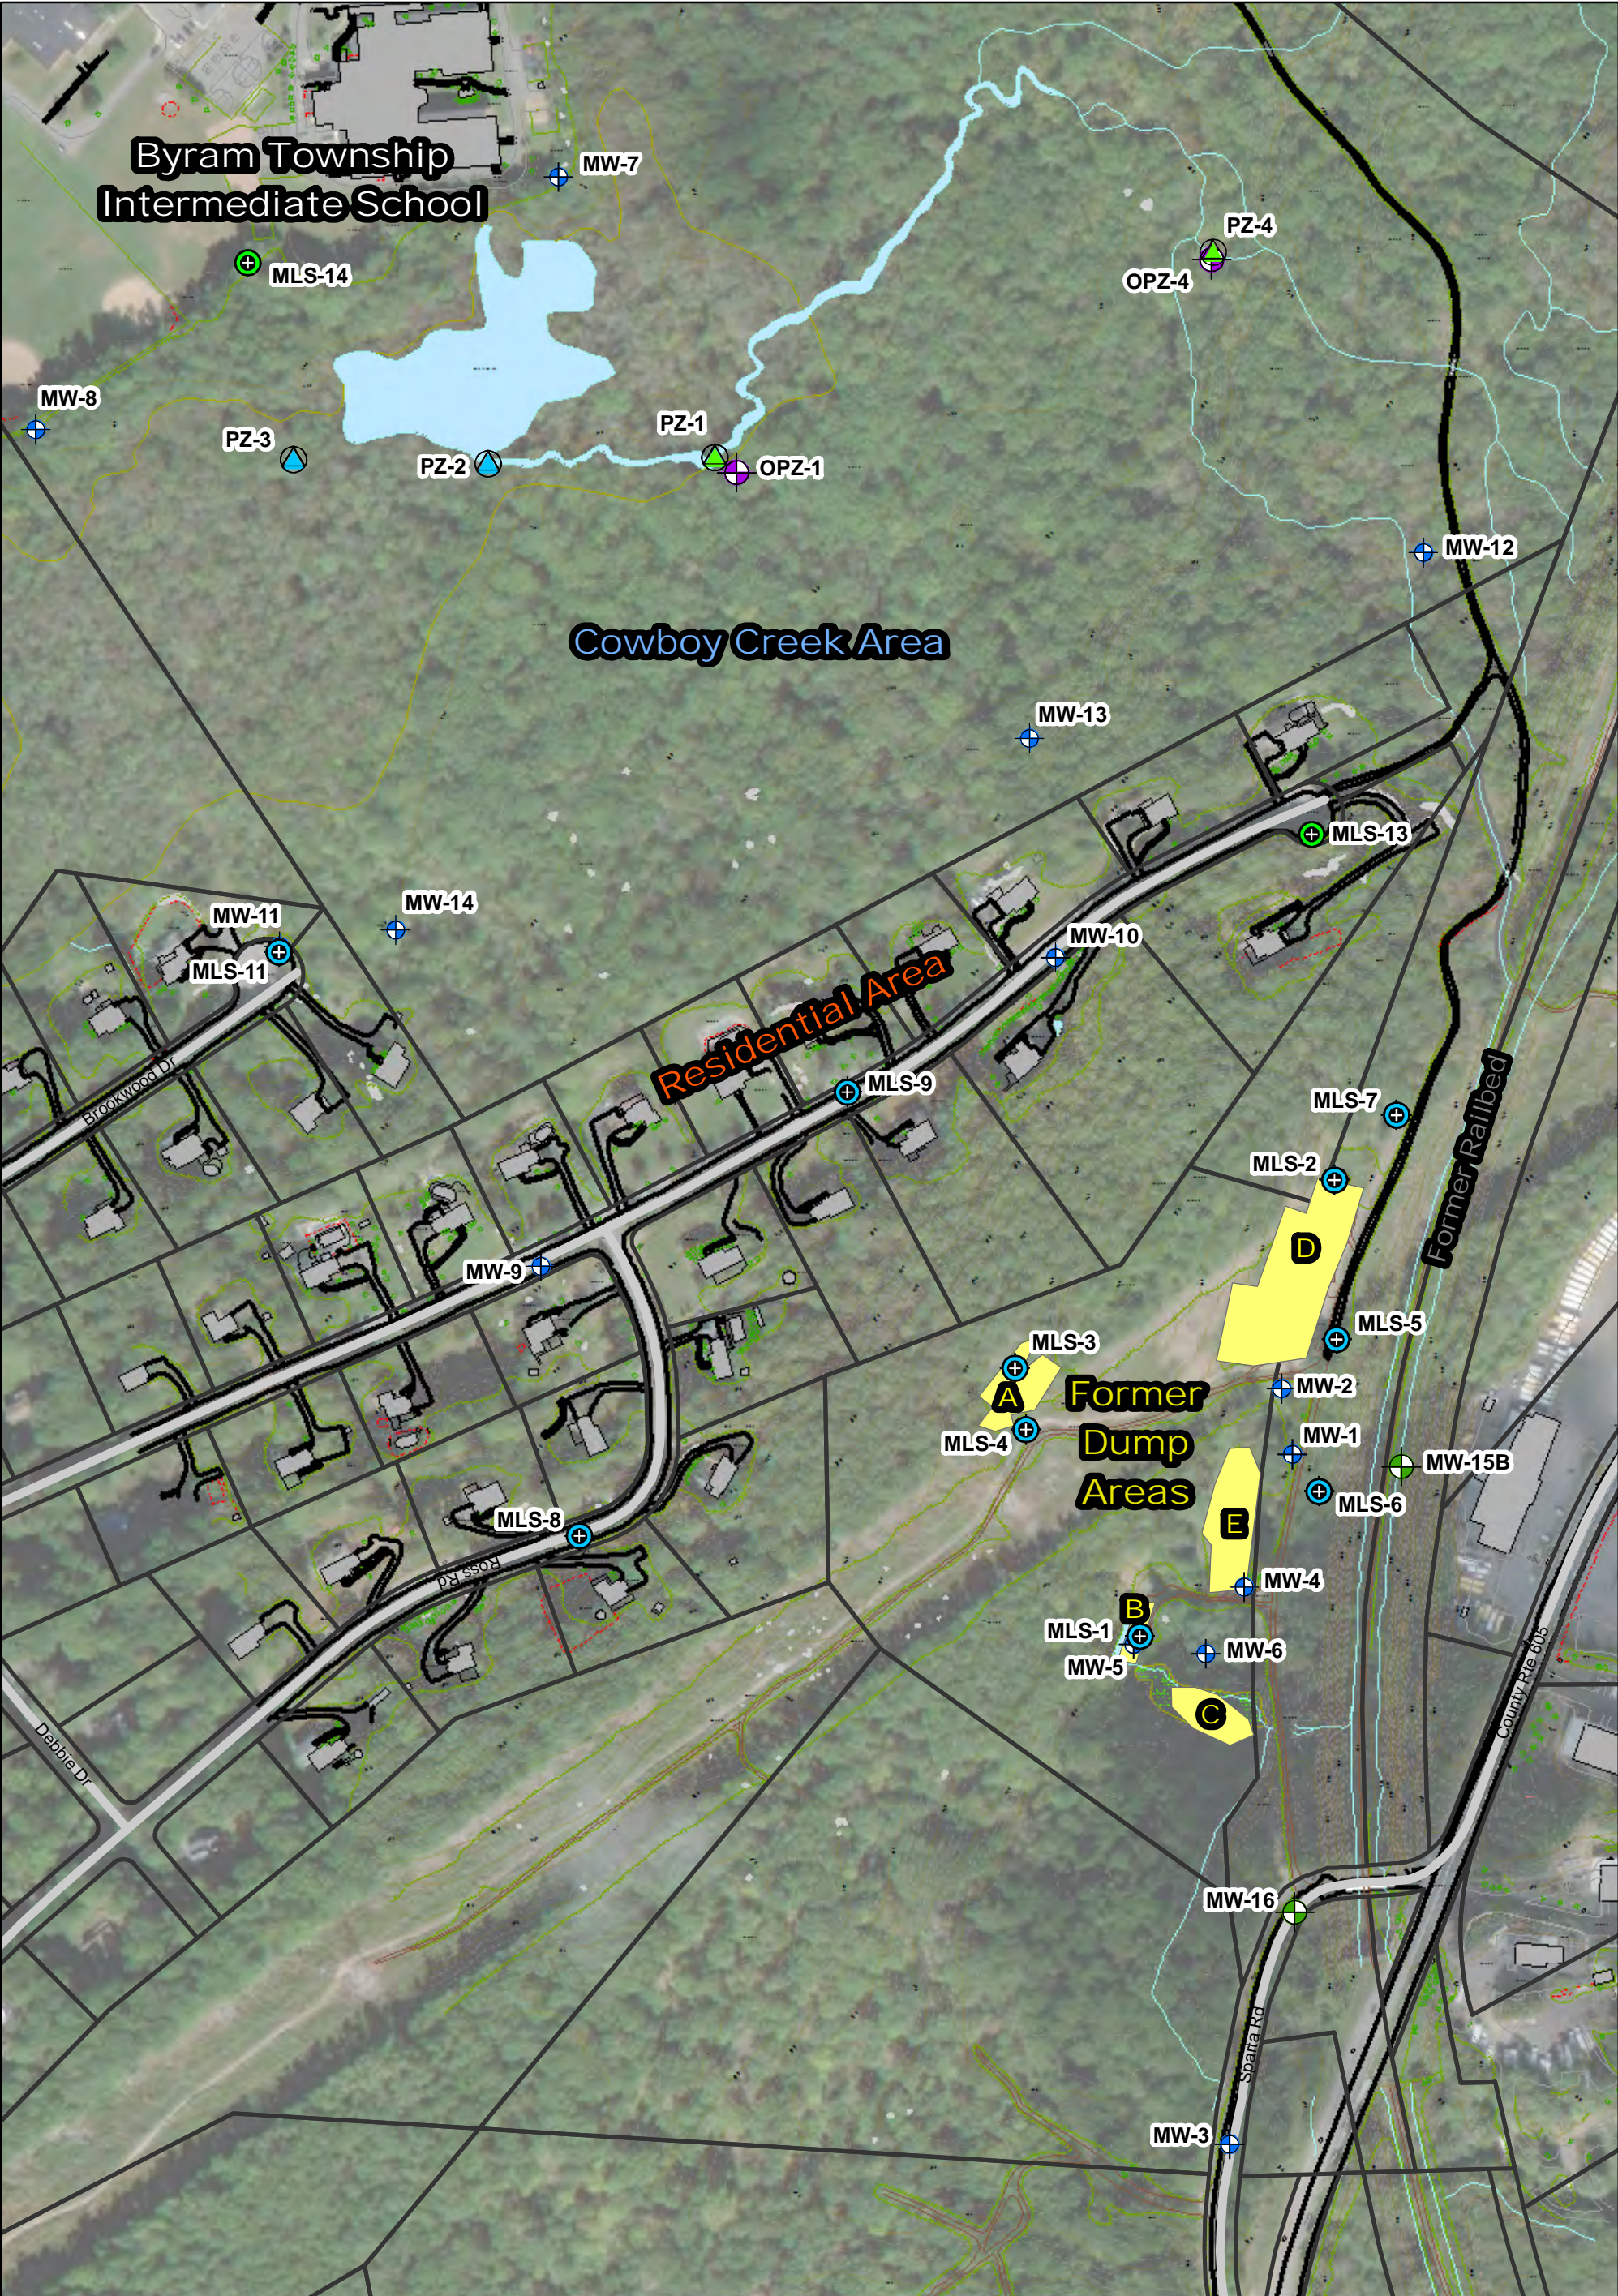
Figure 2-4

Surface Water and Sediment Sampling Locations
Mansfield Trail Dump Site, OU2
Byram Township, NJ

Two paired surface water and sediment samples were collected at locations adjacent to the two sets of in-creek and overburden piezometers at Cowboy Creek. The locations are shown on Figure 2-4. Sub-creek bottom groundwater (sometimes referred to as porewater) was collected from the four creek piezometers and shallow groundwater from the two overburden piezometers concurrent with the groundwater sampling described in Section 2.3. This sampling was conducted to provide information to better understand surface water/groundwater interaction (including whether the stream is losing or gaining) at the site and provide additional information about Cowboy Creek.

Some groundwater flowing along the bedrock topography to the north, or migrating laterally through bedrock, daylight in the residential area as bedrock seeps. Multiple seeps were sampled from the outcrops southeast of Brookwood and Ross Roads in 2017 (Figure 2-4). The saturated overburden north-northwest of the site begins in the residential area. The bedrock and ground surface elevations drop significantly to the northwest of Brookwood Road, and the overburden thickens to the northwest from its emergence at Brookwood Road, becoming saturated closer to ground surface, with the water table eventually converging with the ground surface in the Cowboy Creek area wetland.

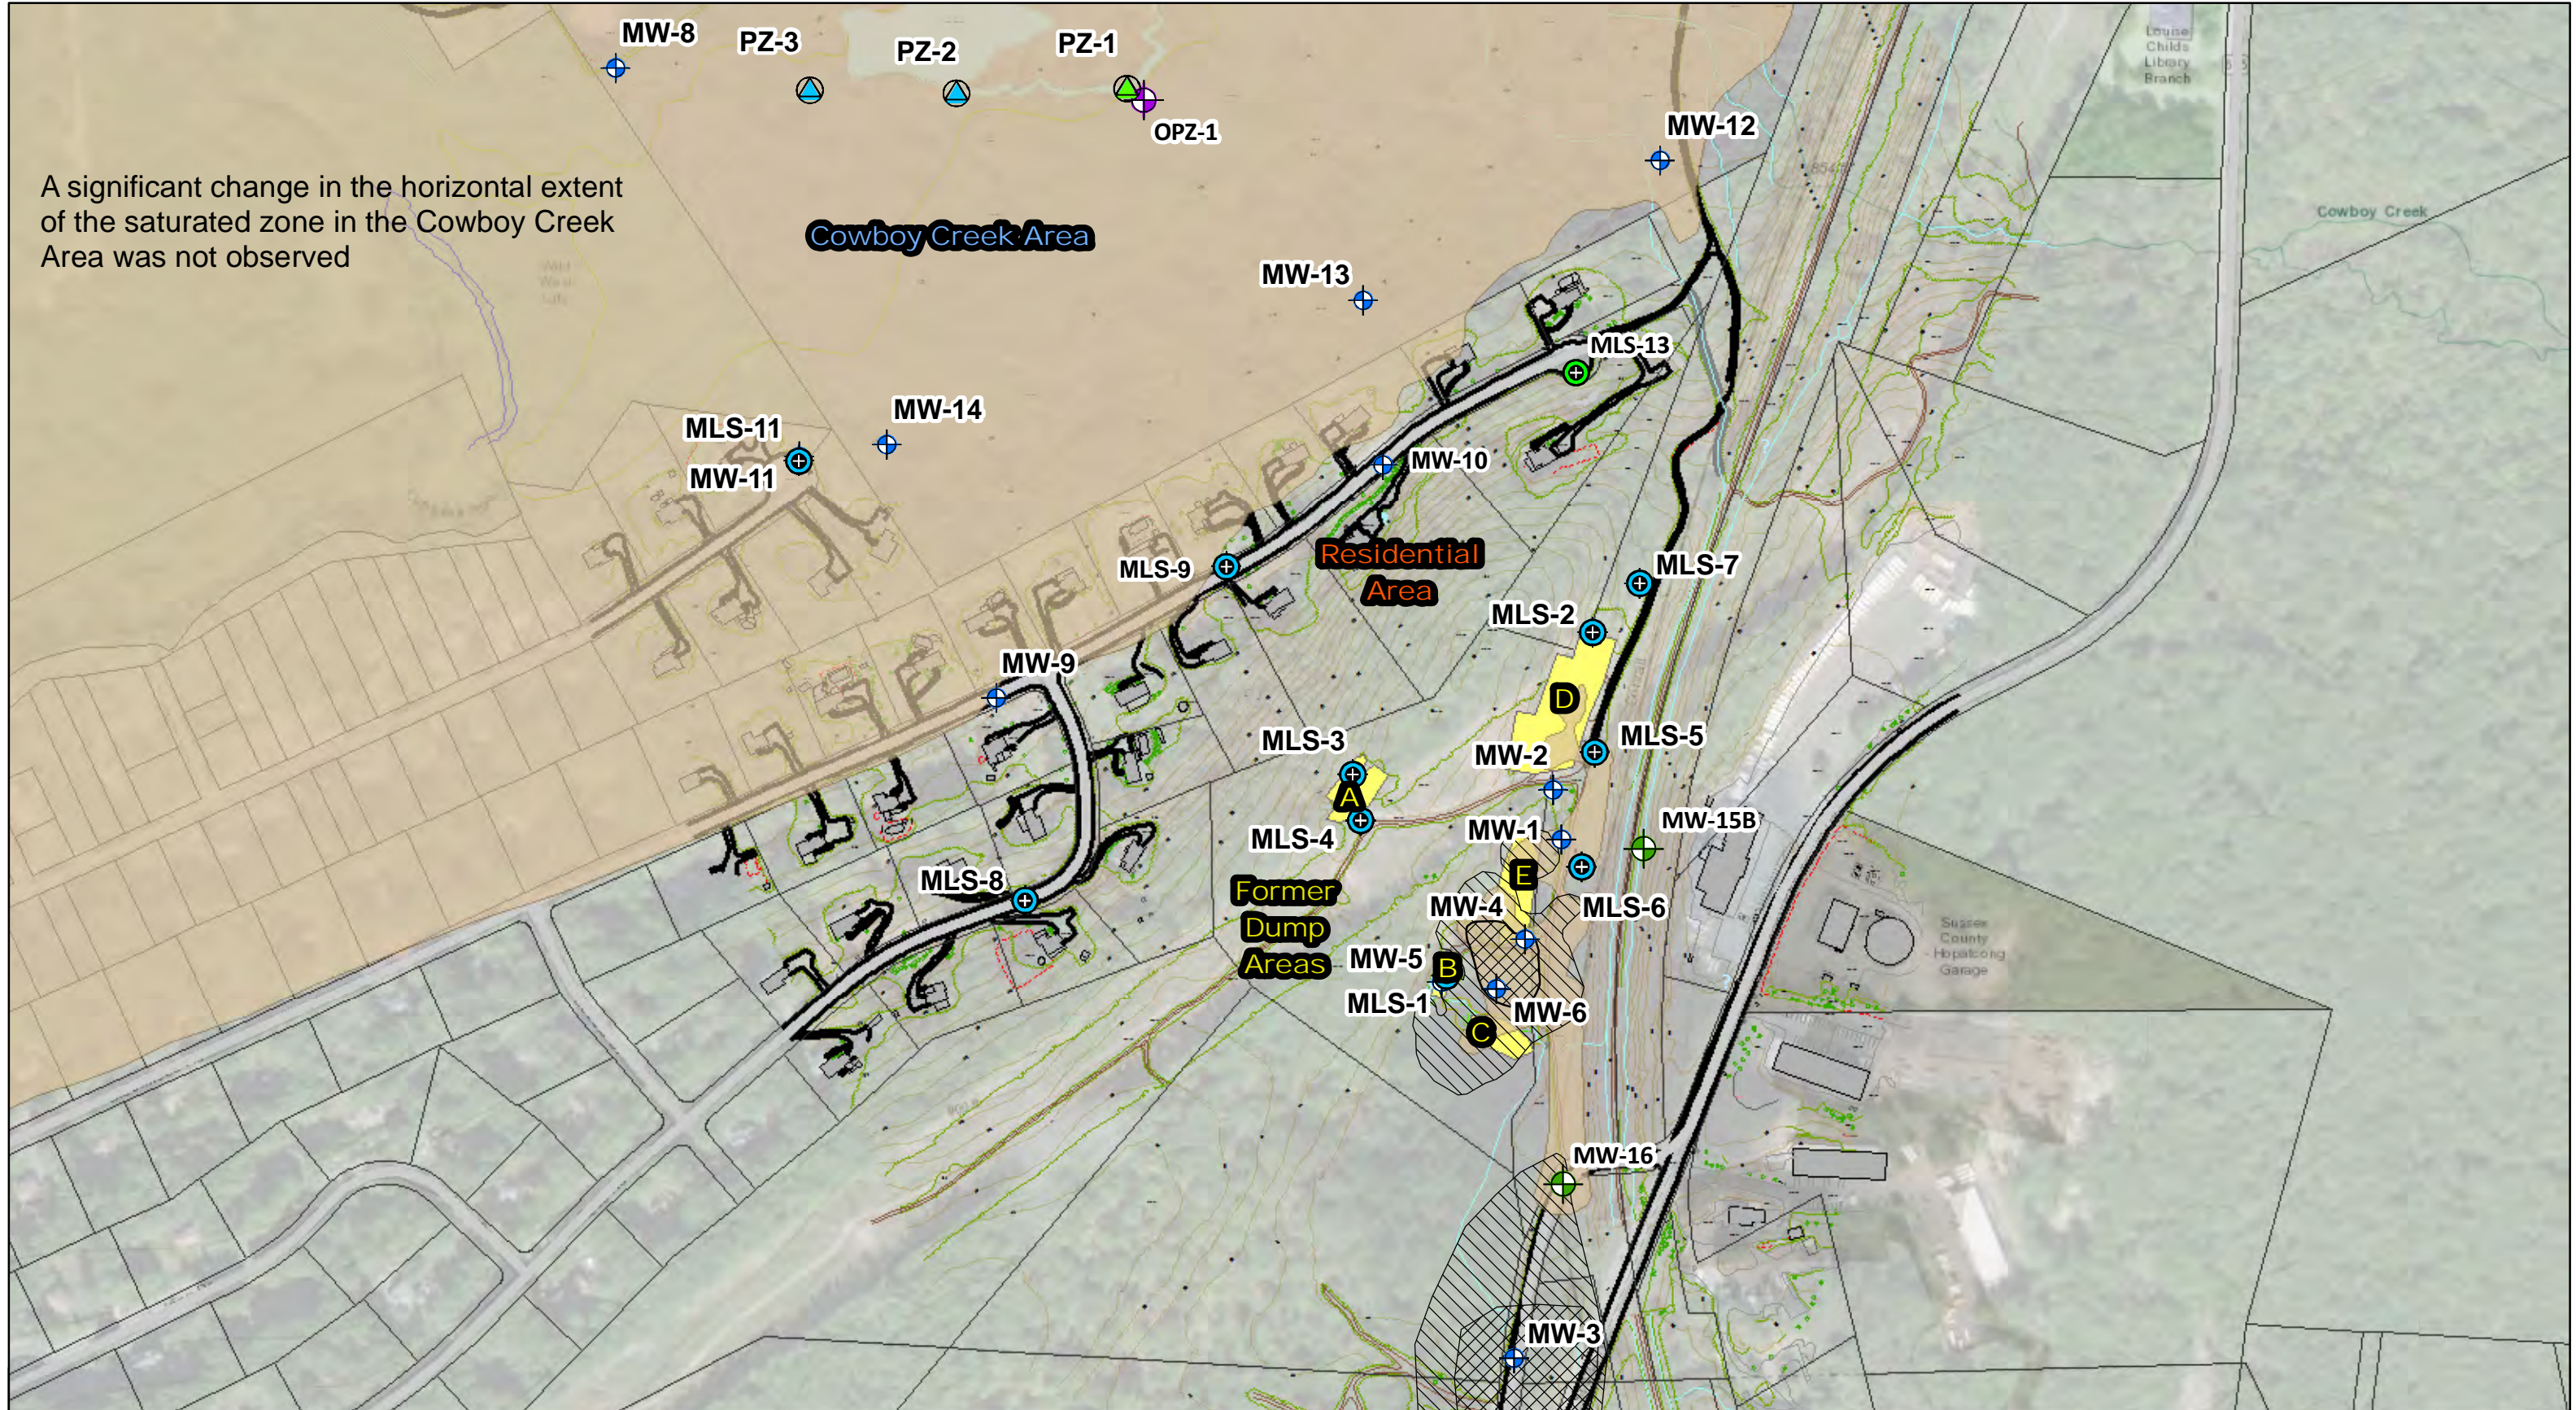
Figure 3-4
Overburden Thickness and Saturated Extent
Mansfield Trail Dump Site, OU2
Byram Township, NJ

A significant change in the horizontal extent of the saturated zone in the Cowboy Creek Area was not observed

- Approximate Extent of Saturated Overburden (December 2015)
- Approximate Extent of Saturated Overburden (January 2018)
- Approximate Extent of Overburden >10 feet thick

- **Overburden** – In the source area, the saturated zones in the overburden are discontinuous and limited to the lower dump areas between the ridge and the former railroad bed. At other locations within the source areas, the overburden is unsaturated because infiltrating rainwater drains into the underlying bedrock surface. The overburden also underlies the residential and Cowboy Creek areas and is typically saturated. Water depths in the overburden range from just below the ground surface in the Cowboy Creek area to greater than the full thickness of the overburden in parts of the source area where the water table lies below the overburden during dry periods. The thickest unsaturated overburden is found in the area of MLS-5 (15 ft).

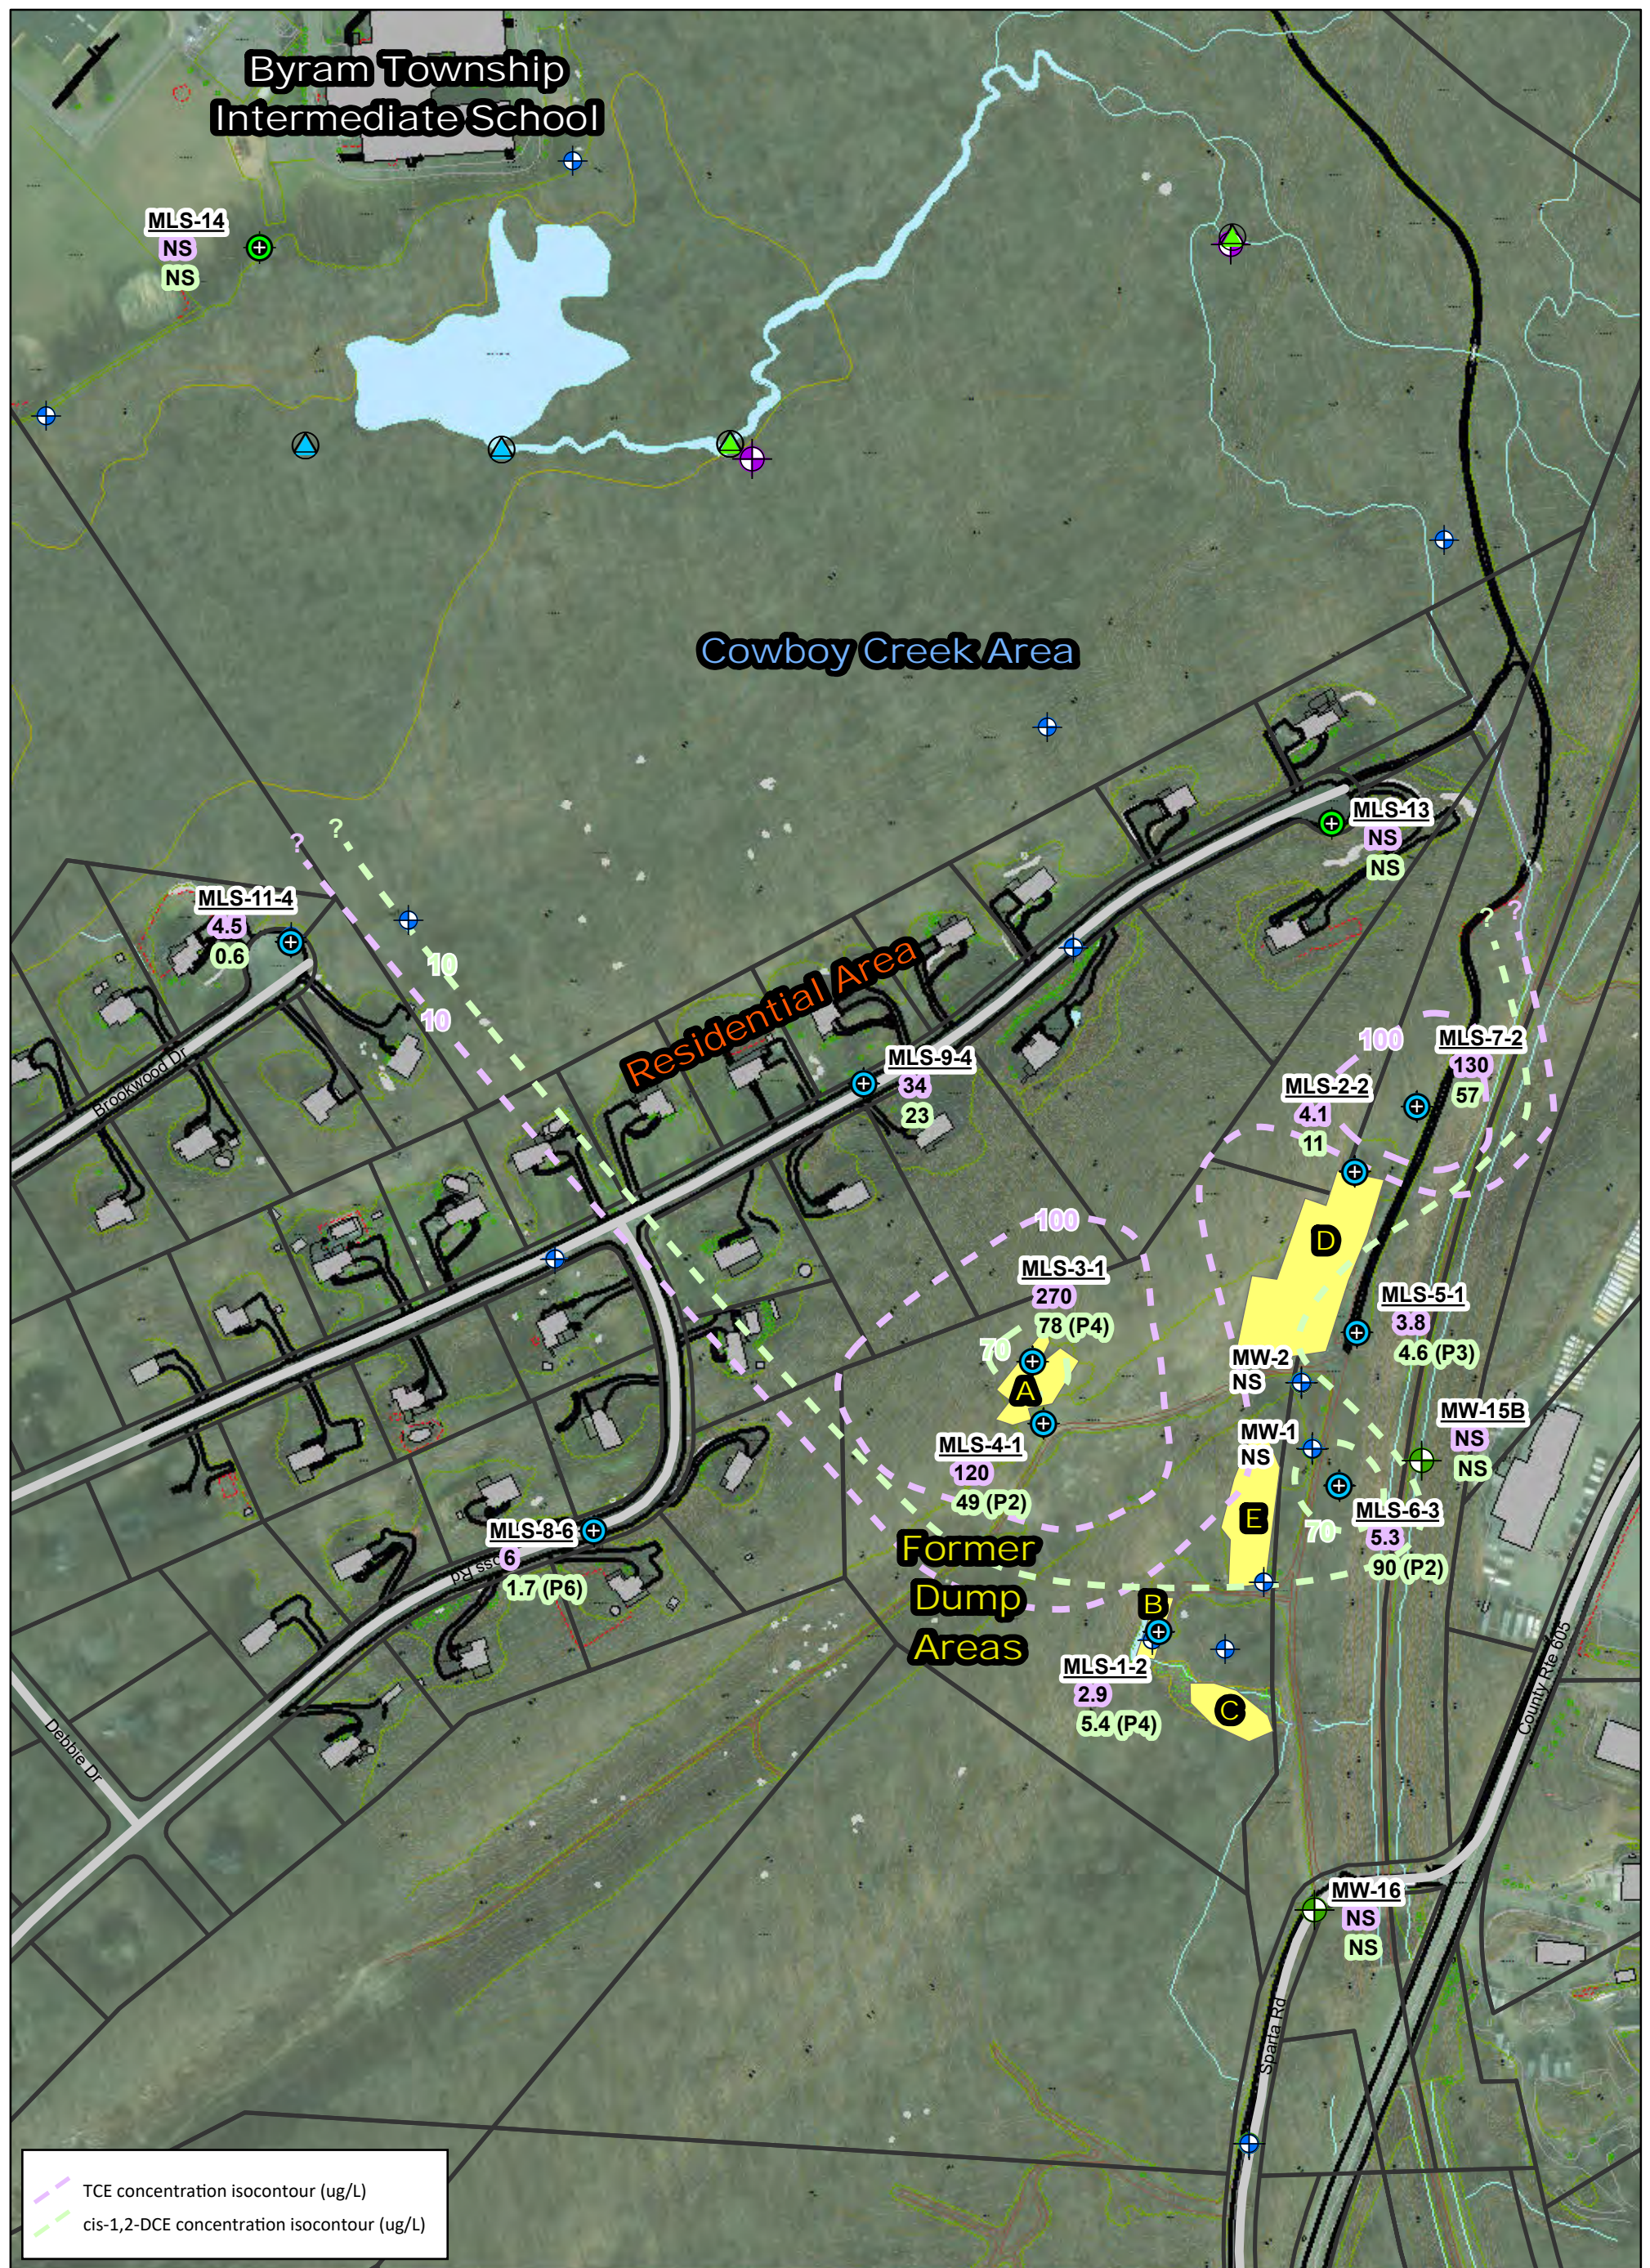
Figure 4-12

TCE and cis-1,2-DCE in Bedrock Groundwater
November 2014
Mansfield Trail Dump Site, OU2
Byram Township, NJ

The data from the November 2014 groundwater sampling event showed a system with low water levels after a period with limited precipitation. TCE concentrations at the water table below the dump areas were more elevated, and contamination generally decreased with depth and was not detected at a distance as far from the source areas or as deep within the deep bedrock flow system as observed in 2017. CVOC contamination in the deeper system contained relatively higher concentrations of cis-1,2-DCE, potentially because TCE from the source areas had not been transported by infiltration and recharge to the deeper groundwater due to the limited precipitation or snow melt at the time.
